## Chloride Pitting of Stainless Steel

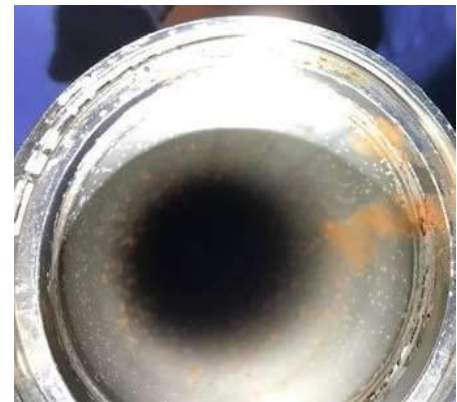
6. If the plant uses brining solutions for their process, very important to not push acid CIP sanitizer with the brine. Recommend a freshwater rinse first! (That was the combination of conditions that led to pitting in the below picture).

Example of chloride pitting of a heating tube in a high salt product processor (taken after CIP).

1. Check plant water for chlorides. Some parts of the country naturally have high chlorides in ground water. Greater than 80 ppm Cl<sup>-</sup> should require special steps to minimize acid mixing with this water.

2. Reduce acid washes on CIP, by substituting with high chelation caustic wash, and reduce frequency of acid recirculation.
3. Minimize lines sitting with acid sanitizer and high chloride water. Sanitize just before production and flush out if needed.

4. Reduce temperature of acid washes – higher temps accelerate pitting.
5. Suggest upgrading process equipment to 316 SS or AL6XN SS – chloride resistant stainless for cheese brines. (Note most sanitary valves are usually already made from 316 SS, but pipes and tanks are 304 SS due to cost).
