CASE STUDY

Restoring Cooling Tower Efficiency After Hard Water Contamination

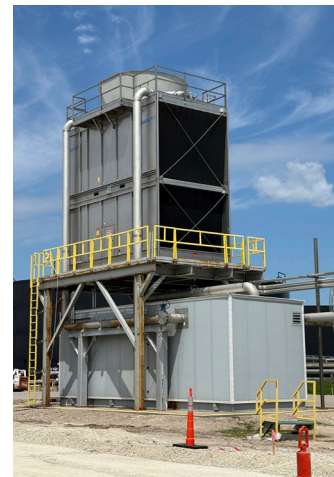
Hydrite deployed its proprietary diagnostic software to assess the system. The analysis revealed **significant fouling and scale accumulation** across critical heat transfer surfaces. Visual diagnostics (see images) confirmed the extent of the damage and pinpointed areas of concern.

One key finding was the performance of the heat exchanger. It was receiving cooling tower water with the control valve fully open at 100%, yet the system was unable to meet its temperature set point. The target temperature was 132°F, but the actual temperature reached 152°F—a full 20°F above set point, indicating severe inefficiency and restricted heat transfer.

- Performed a full Clean-In-Place (CIP) procedure using Hydrite's proprietary **Pureflux™**, a chemistry compatible with all system metallurgy which effectively removed scale and fouling without damaging sensitive components.

- Introduced **Hydricare™**, Hydrite's advanced treatment technology engineered for hard water environments which prevented further scale formation, restored full system capacity, and ensured optimal heat transfer efficiency.
