Equipment Staining – Causes and Removal

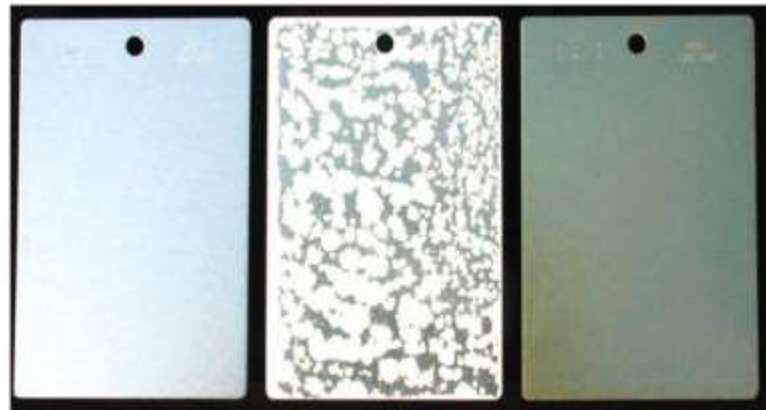
This is an example of rouging stain which is a corrosion product.

New Galvanized

Steel White Rust Corrosion

Passivated Galvanized Steel

- Heat Stain:** The surface discoloration on stainless steel after grinding or welding is surface oxidation. At elevated temperatures, the metal comprising the stainless steel will combine with oxygen to form an oxide layer on the metal surface. The color of the “stain” is a function of the layer thickness.
- Rouging:** A phenomenon that is most observed in the pharmaceutical industry but can also be observed in the food industry at times. Rouging is a reddish-brown film of iron oxides and hydroxides and is found usually in ultra-pure water systems. The rouging film mainly contains iron (ferric) oxides, but also can contain chromium and nickel compounds which can give different colors to the stain (rouge).
- White Rust:** This is a form of corrosion of galvanized steel and is typically found in cooling towers of various food plants.
